# Alternate Nozzle Ablative Materials Program

N. A. Kimmel

September 1, 1984

Prepared for  
**NASA Marshall Space Flight Center**  
through an agreement with  
**National Aeronautics and Space Administration**  
by  
**Jet Propulsion Laboratory**  
California Institute of Technology  
Pasadena, California

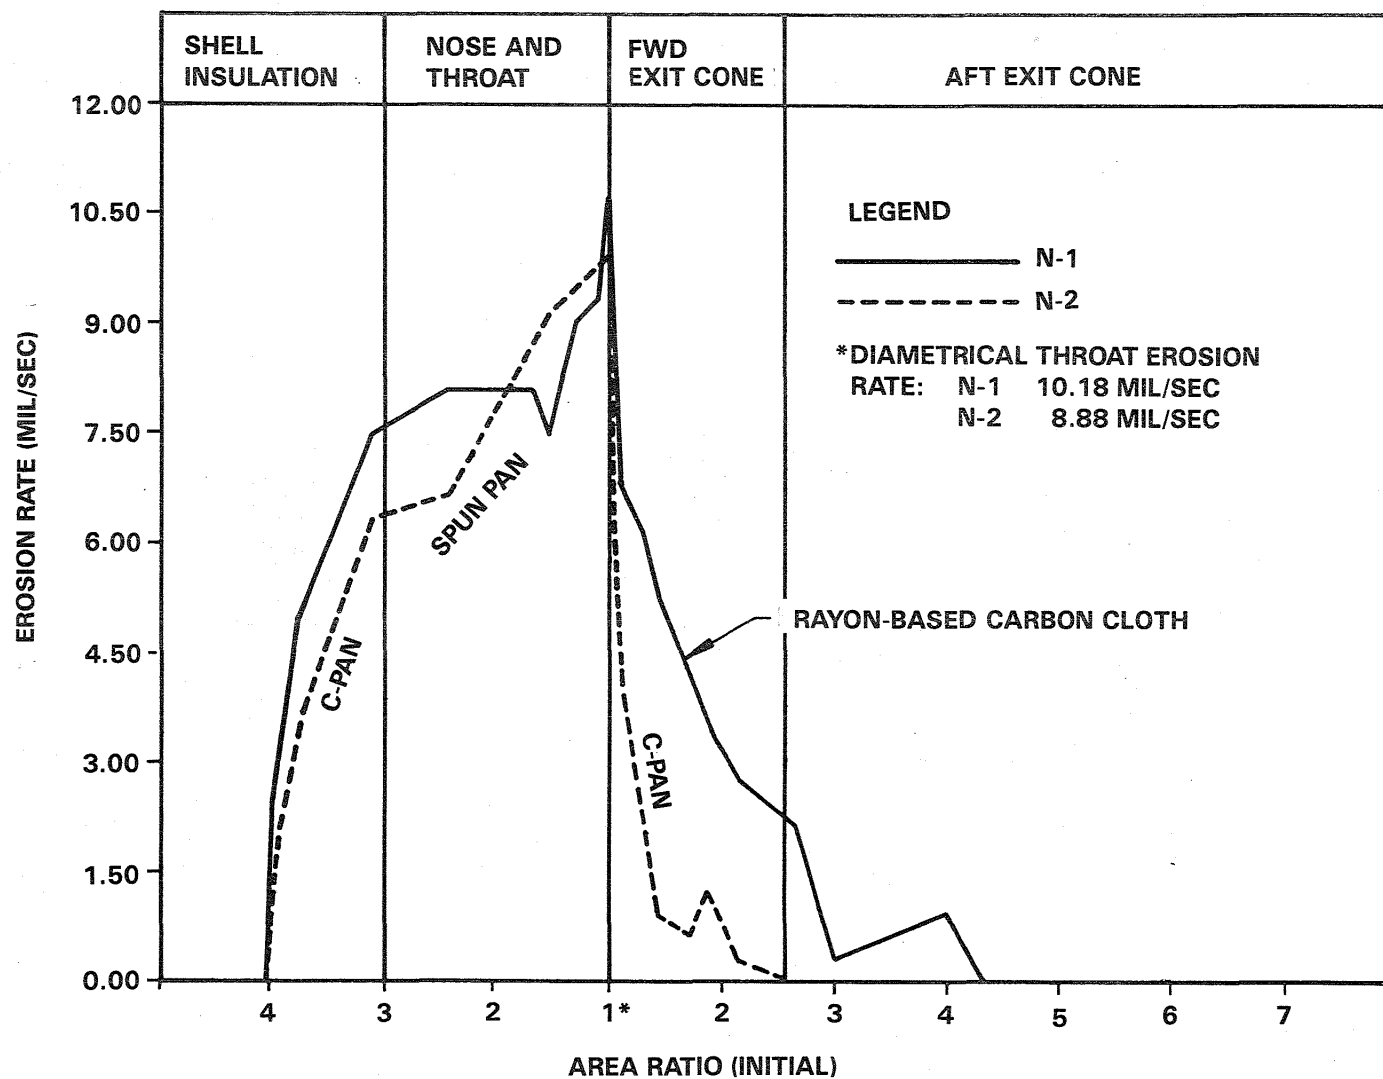
Figure 17. Erosion Rate vs Area Ratio Based on Nozzle Cross Sections

A comparison of the N-1 and N-2 nozzle erosion rates as a function of initial area ratio, is presented in Figure 17. These data are based on an average of four cross-sectional erosion measurements. Erosion data in the aft portion of the aft exit cone are somewhat questionable due to material swelling and some localized spallation.

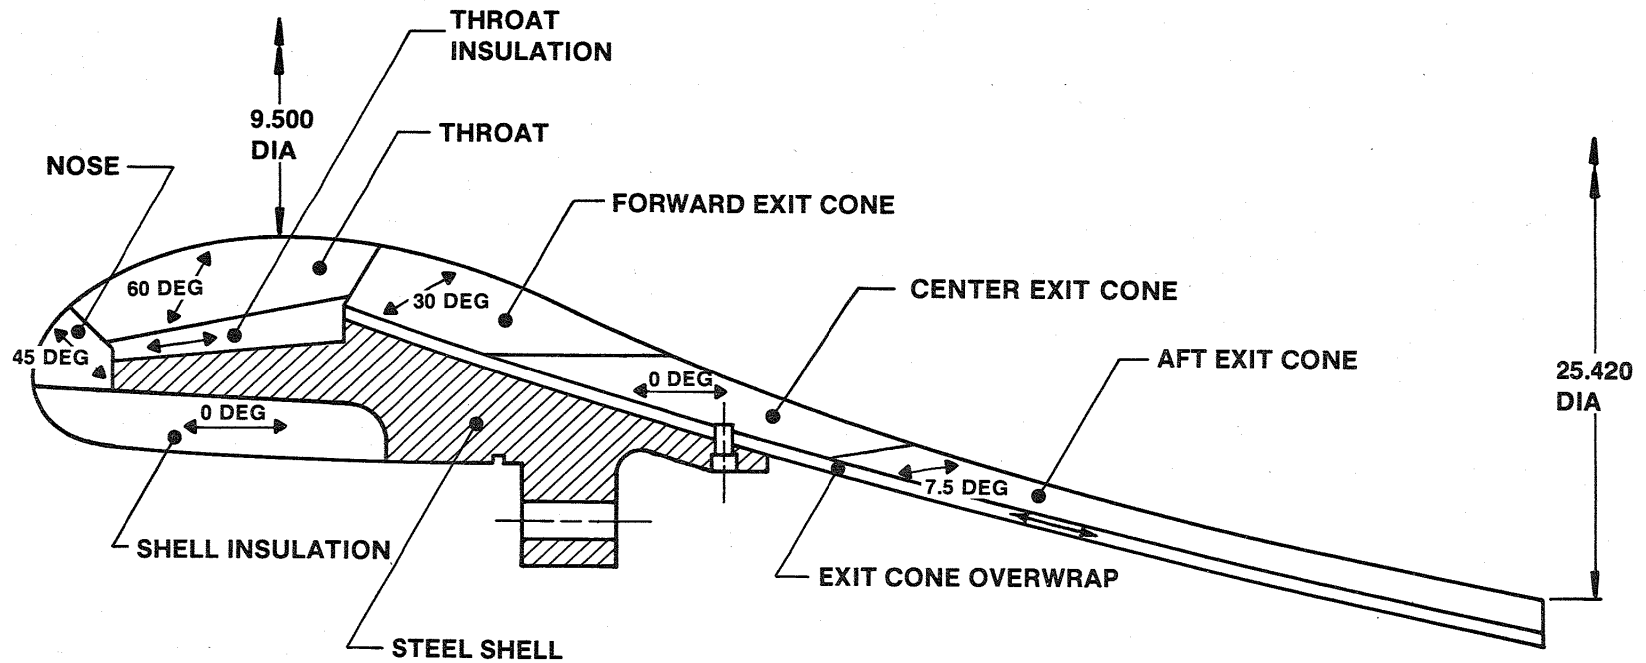
Figure 1. Subscale Space Shuttle Nozzle Description

(REFERENCE DRAWING 7U52387)

The nozzle is a fixed, partially submerged design consisting of a steel shell, shell insulator, nose ring, throat ring, and exit cone section. Overall geometry and contour simulate those of the full-scale SRM nozzle. The N-3 nozzle is shown in Figure 1.

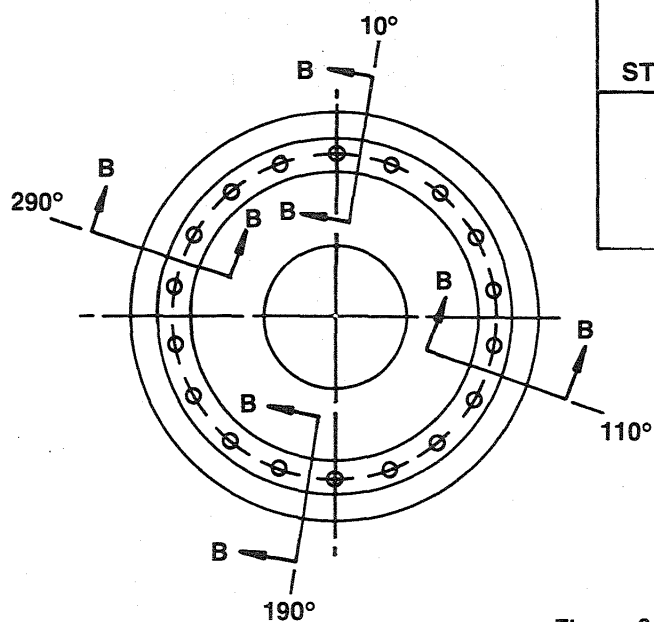
Figure 3. N-3 Nozzle Thermocouple Locations

| STATION | PLANE (DEG) | DEPTH BELOW FLOW CONTOUR (IN.) | THERMOCOUPLE TYPE |
|---|---|---|---|
| 1-4 | 190 | 0.4 | CHROMEL/ALUMEL |
| 1-4 | 290 | 0.5 | CHROMEL/ALUMEL |

Figures 3 and 4 show the thermocouple locations and required/measured hole depths. Sixteen thermocouple probes were located in the exit cone--4 each at depths of 0.2, 0.3, 0.4, and 0.5 in. at expansion ratios of 2.0, 3.3, 5.0, and 6.2.

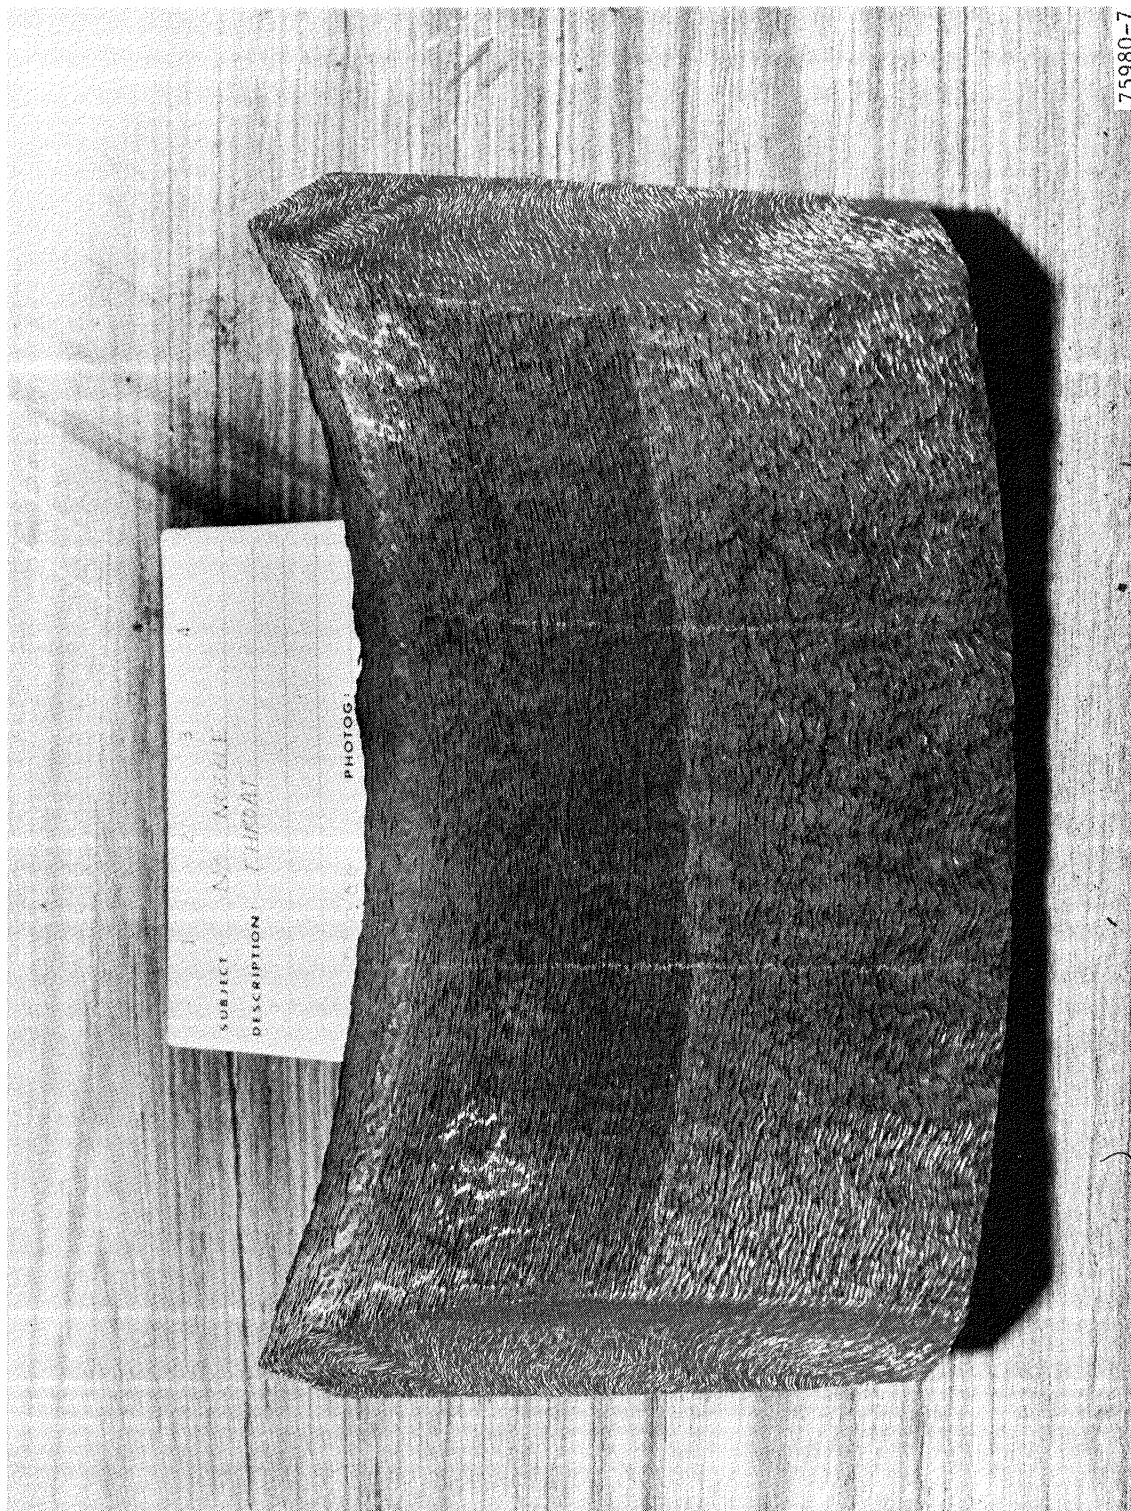
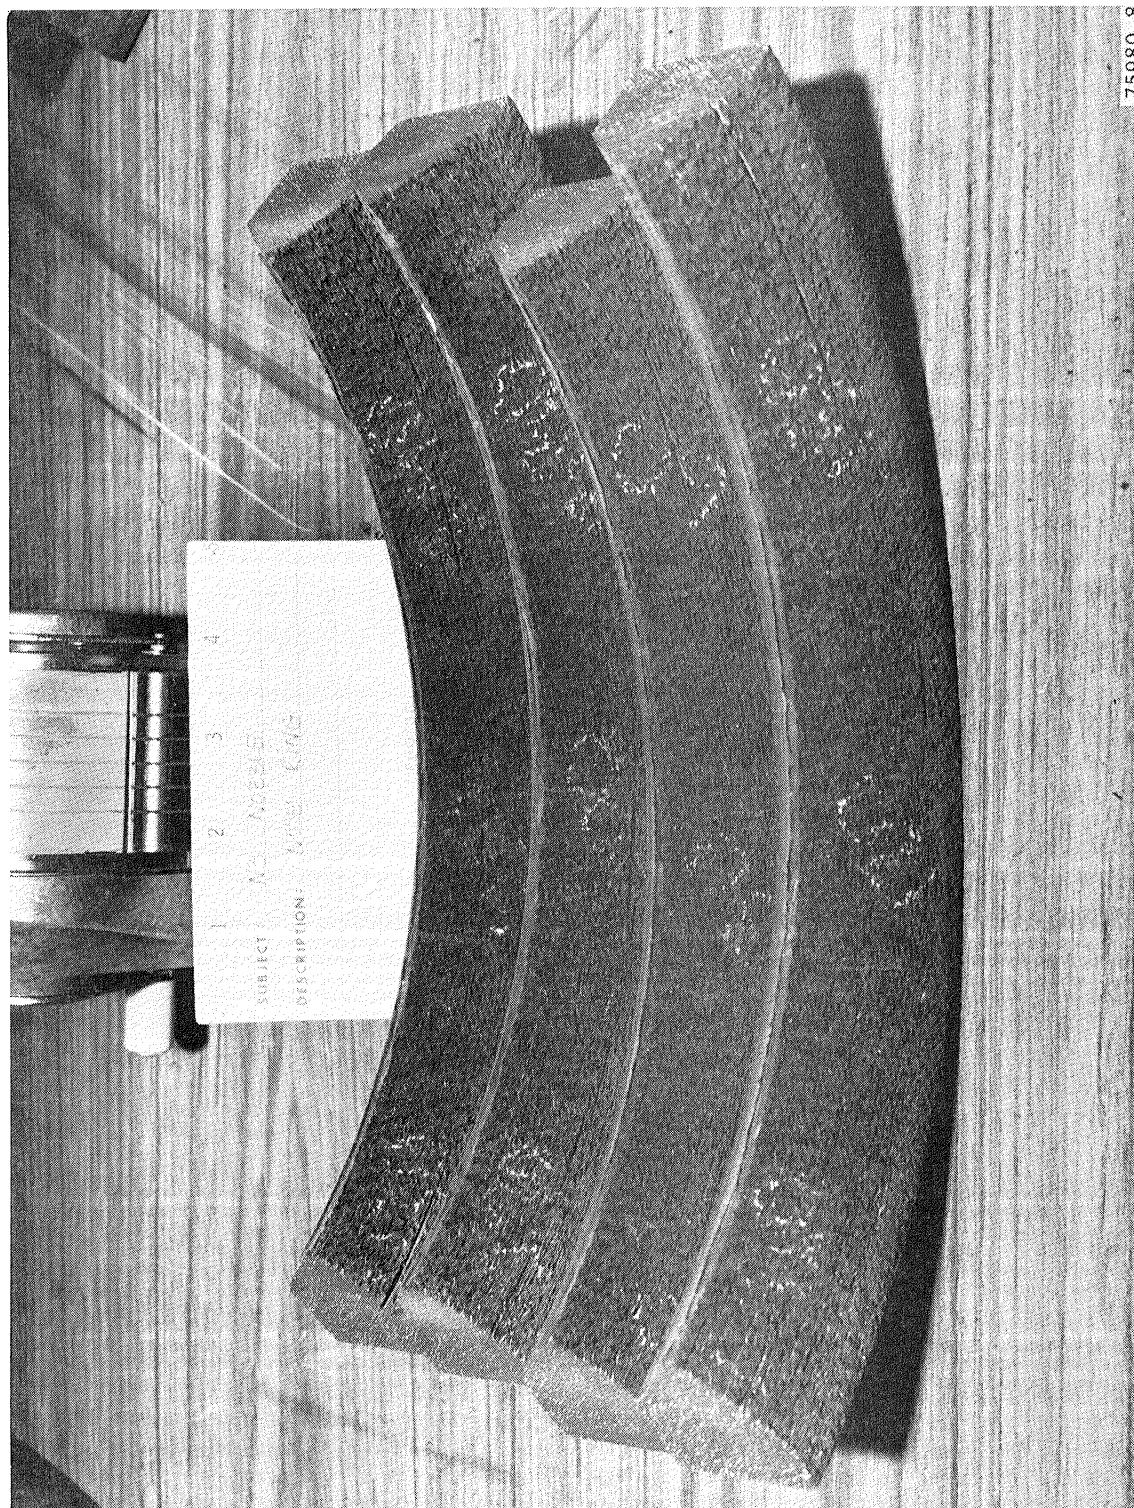
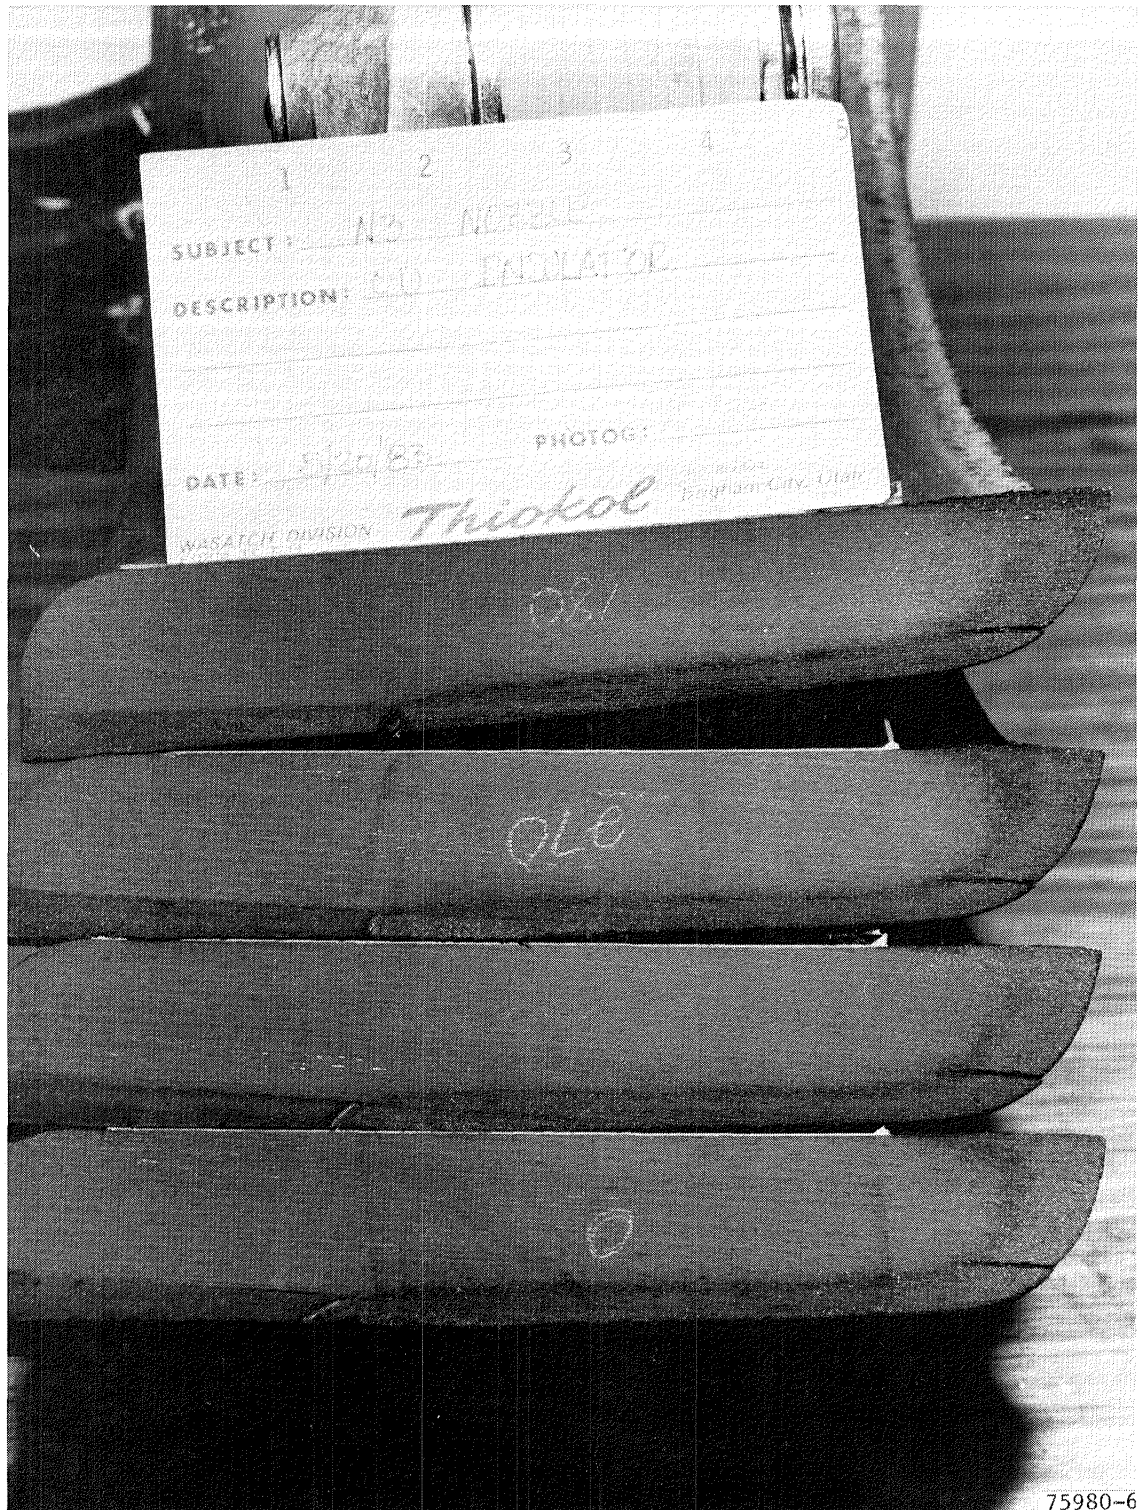
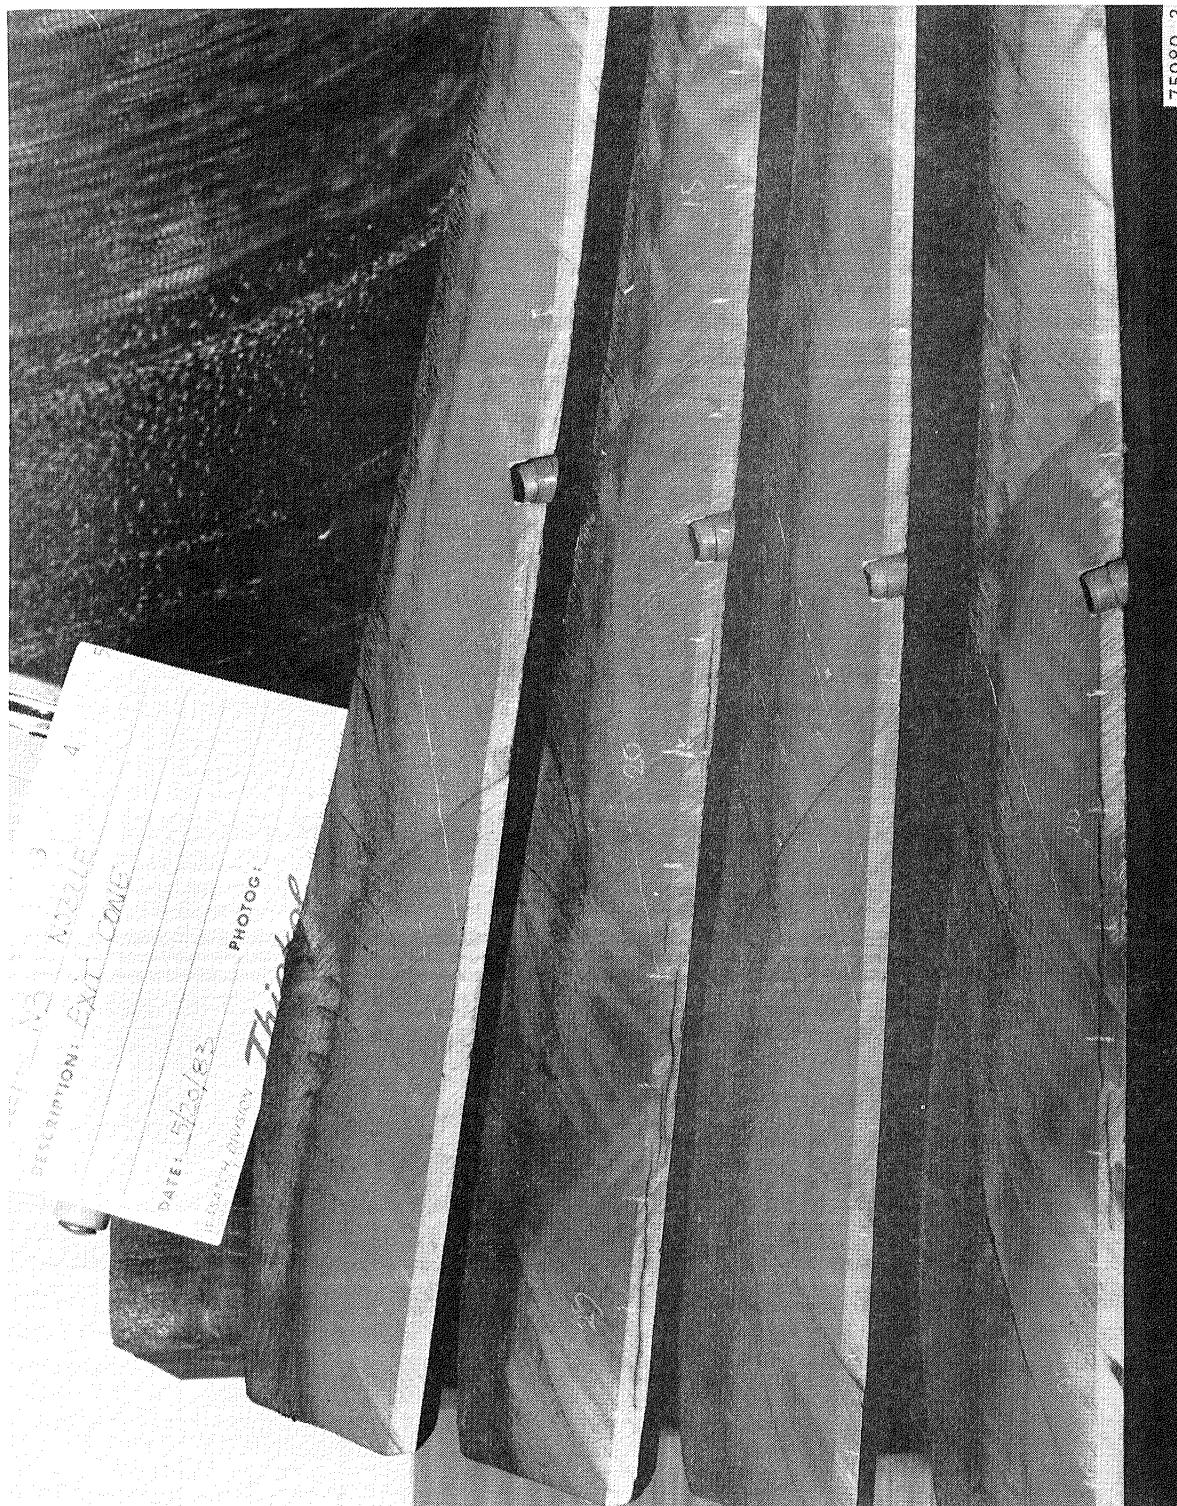
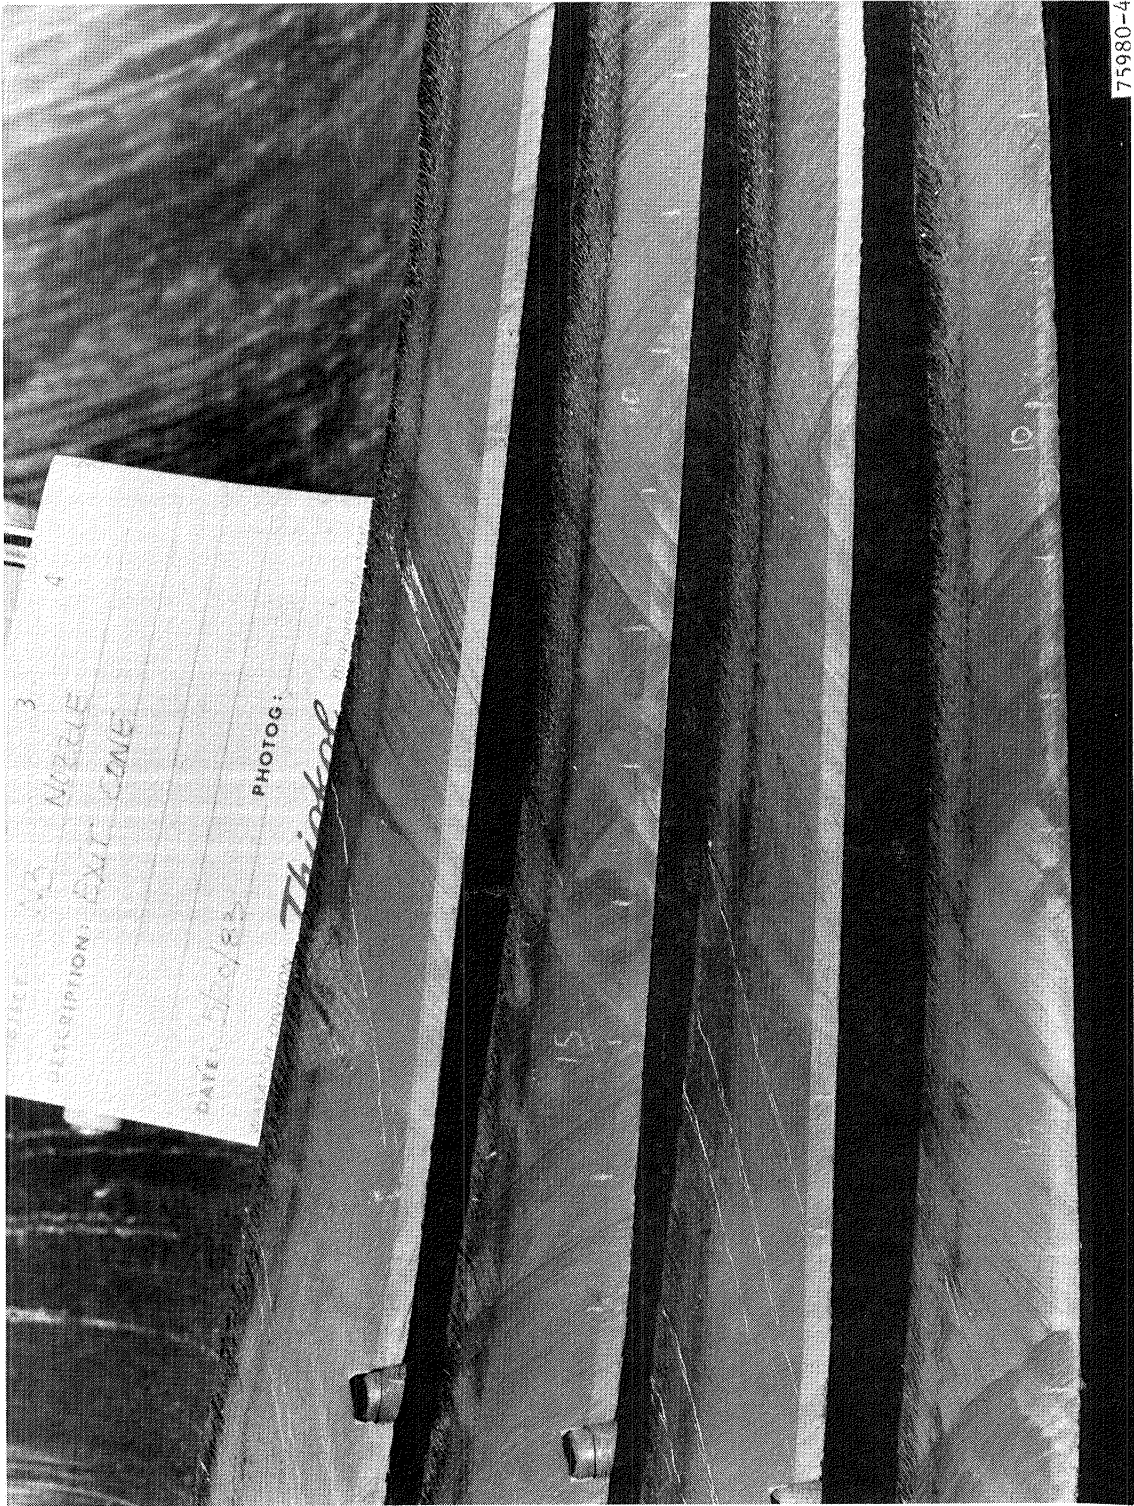
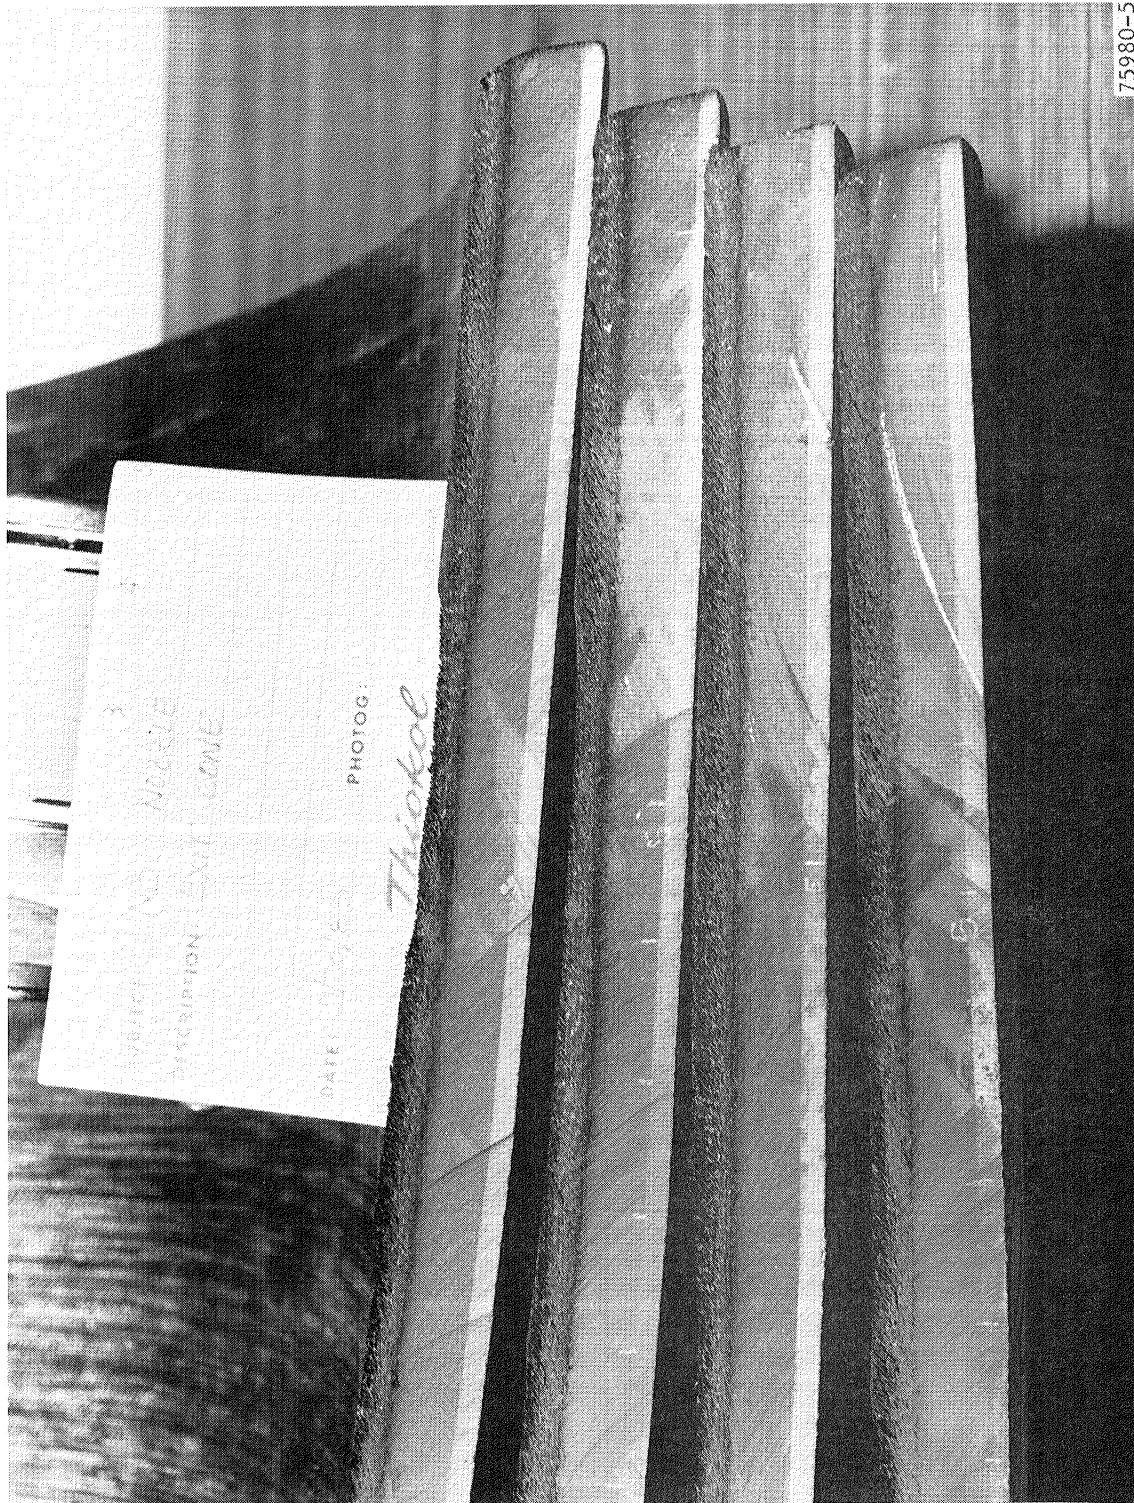
The nozzle was in good post-test condition and there were no major anomalies. The throat and nose sections of pitch material showed good integrity. There were no delaminations in the throat even though it charred completely through. The nose ring was unbonded from nozzle, had several delaminations, and was charred completely through also. Both pitch parts had excellent char integrity.

The exit cone performed similar to the past tests. The forward exit cone wrapped 30 deg to centerline showed no delaminations but a fairly deep char. The center exit cone section performance was good with no anomalies. The low density PAN aft exit cone showed minor erosion and some lifting of plies and some spallation.

The glass throat insulation experienced surface char and had three hoop fractures with evidence of char in the cracks.

The metal housing showed no indication of damage but was somewhat discolored by heating for plastic parts removal. The post-test conditions of the plastics are shown in Figures 9 through 16.

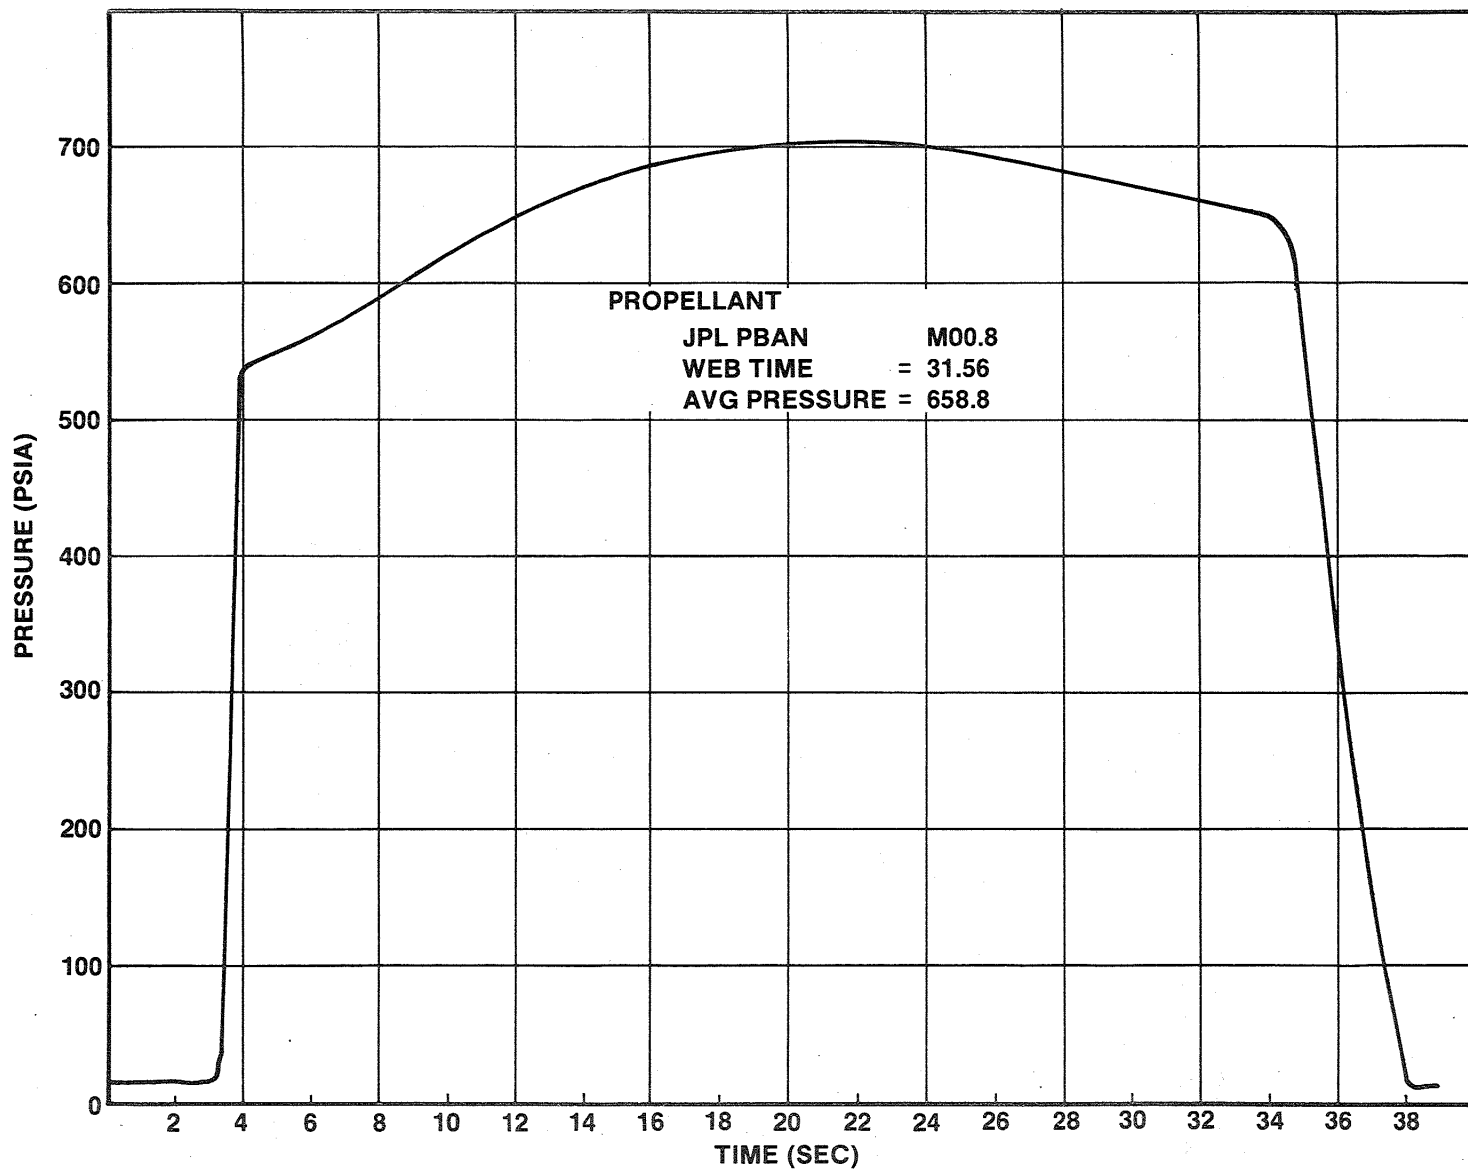
Figure 18. Motor Chamber Pressure

Figure 17 shows the JPL test motor and Figure 18 presents the pressure-time trace for the N-3 motor. The average web burn pressure was 658.8 psi and the web time was 31.56 sec.

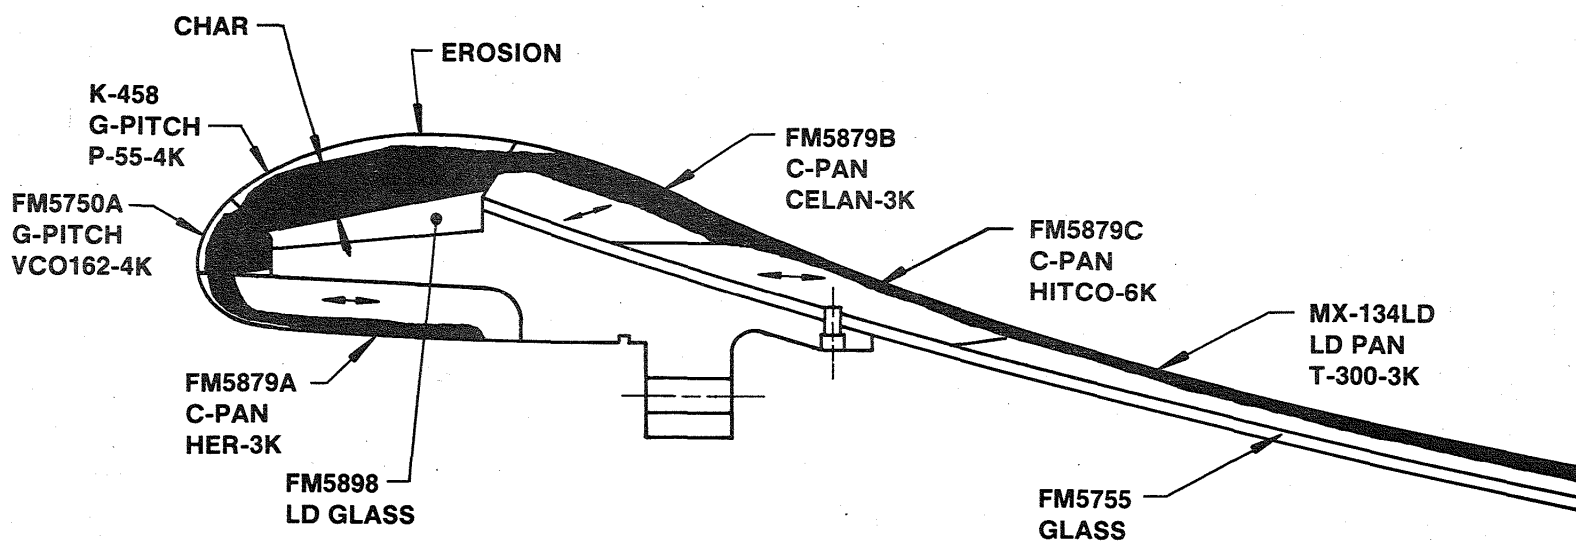
Figure 19. N-3 Nozzle Typical Erosion and Char Profile

658.8 PSI FOR 31.56 SEC  
THROAT EROSION RATE = 8.6 MILS/SEC

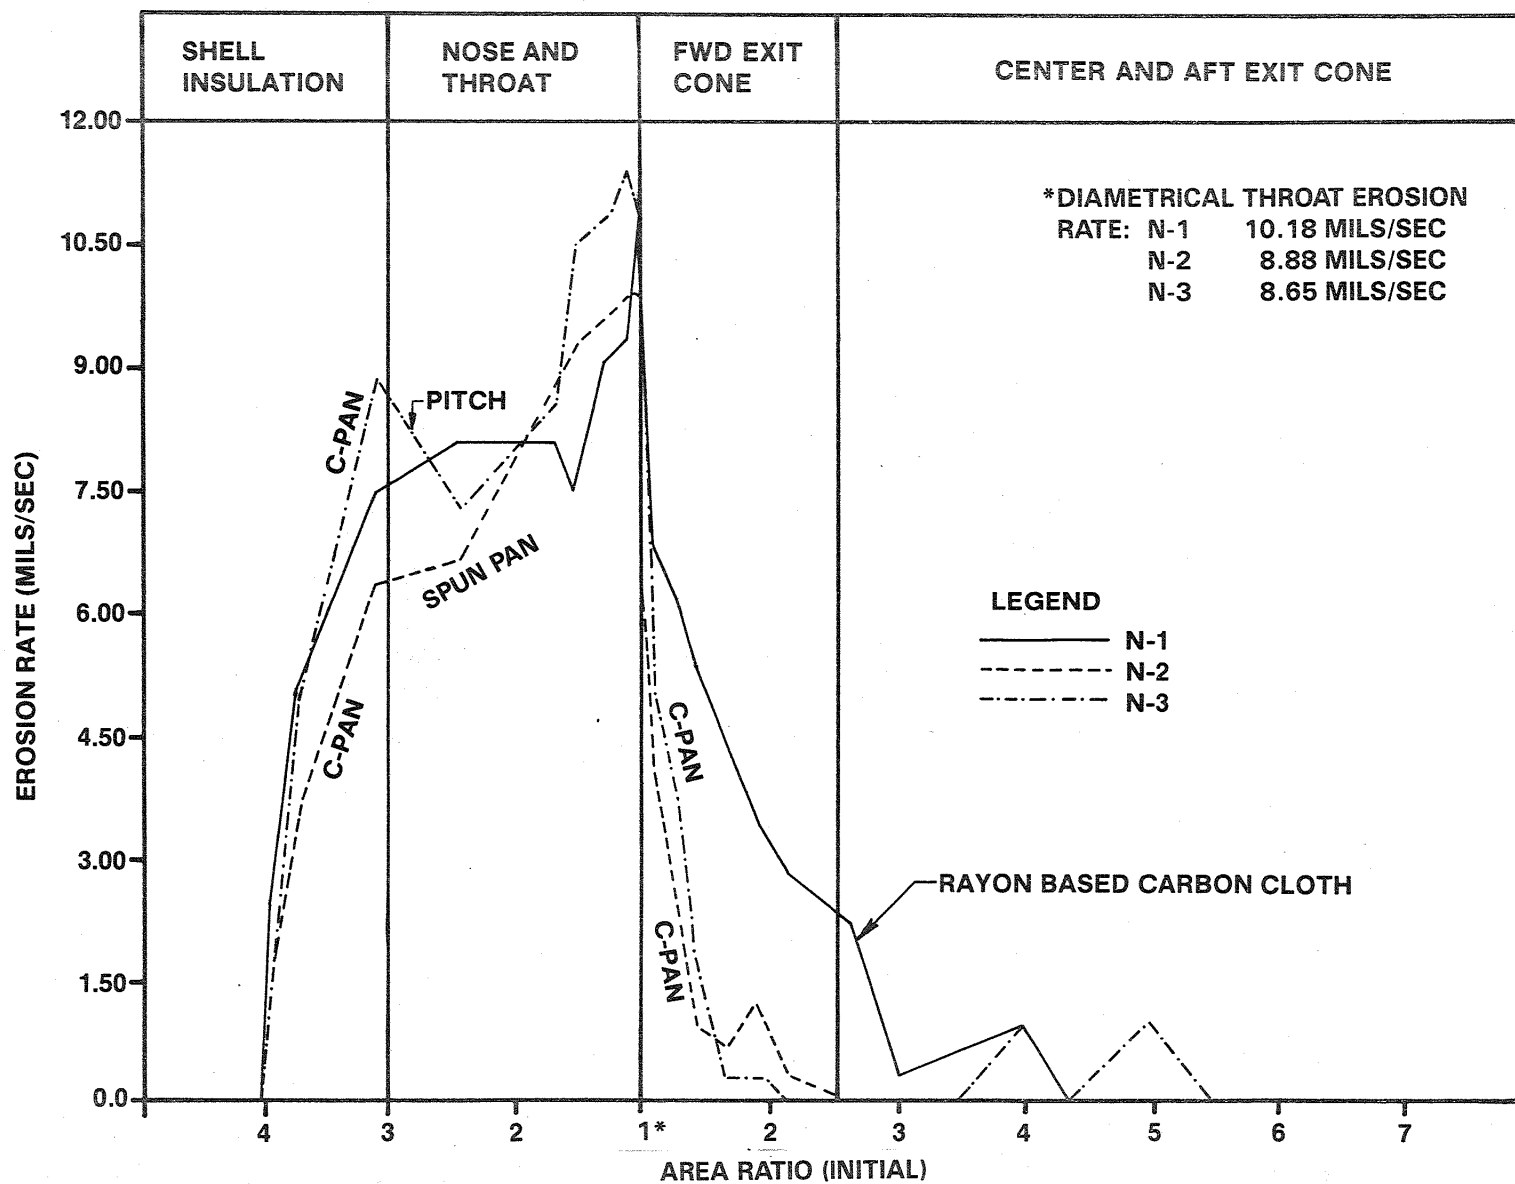
Figure 22. Erosion Rate vs Area Ratio Based on Nozzle Cross-Sections

A comparison of the N-1, N-2, and N-3 nozzle erosion rates as a function of initial area ratio is presented in Figure 22. These data are based on average cross sectional measurements. The filled PAN, located in the shell insulator, forward, and center exit cones, eroded similar to the unfilled PAN on N-2, and less than the baseline materials in N-1. The low density PAN, located in the aft exit cone, eroded about the same as the baseline material; however, the data are somewhat questionable due to the material swelling and some localized spallation.
